Canon PIXMA MP190 Scan Bed Removal

A dirty scan bed will cause poor scan or copy quality. Cleaning of the scan bed will remedy this issue.

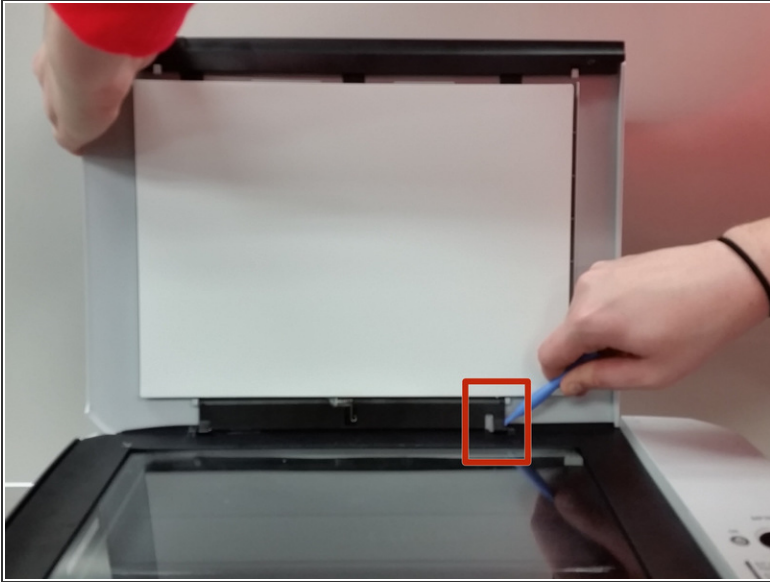
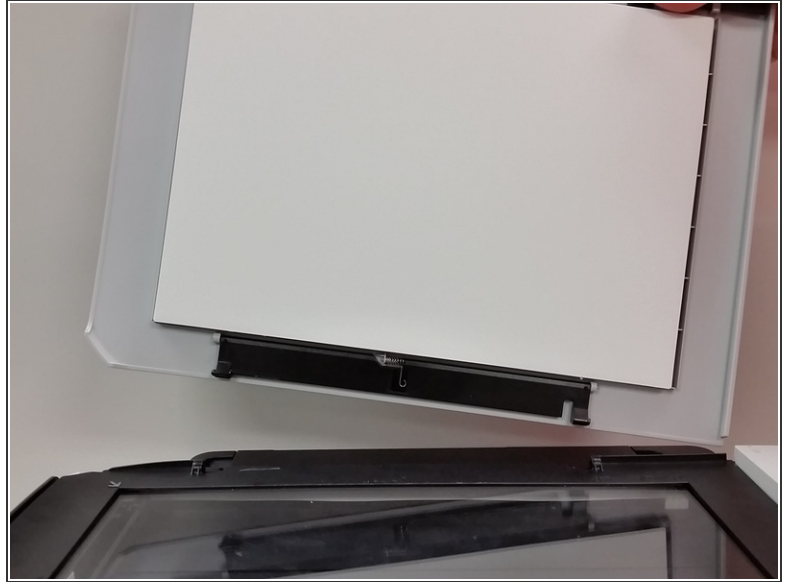
Step 1 — Remove Scanning Bed Cover

- Lift scanning bed cover with one hand, and pry the right hinge inward using a plastic opening tool.
- The cover will lift up and away from the printer.

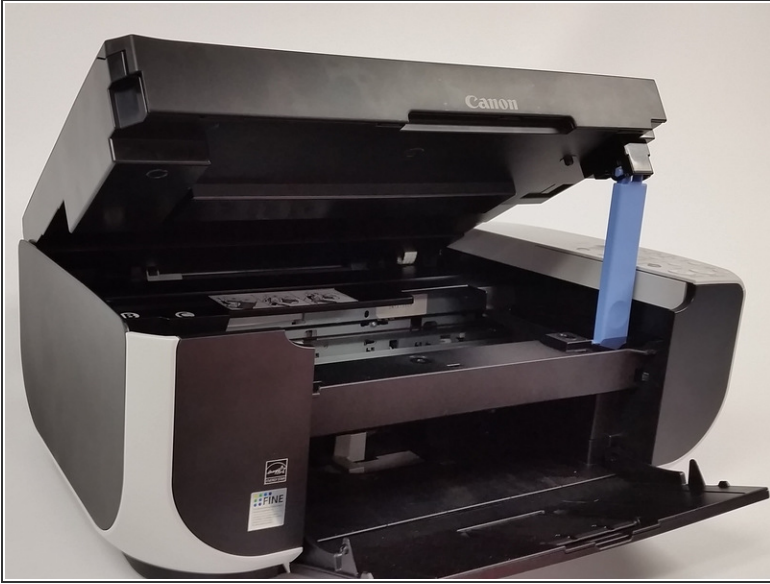
Step 2 — Accessing Scan Bed

- Lift the scan bed into the upright position.
- Ensure the scanning unit support seats into the scanning unit support slot.
- The four arrow markers located on the bottom edge of the scan bed mark the four tabs that must be released.

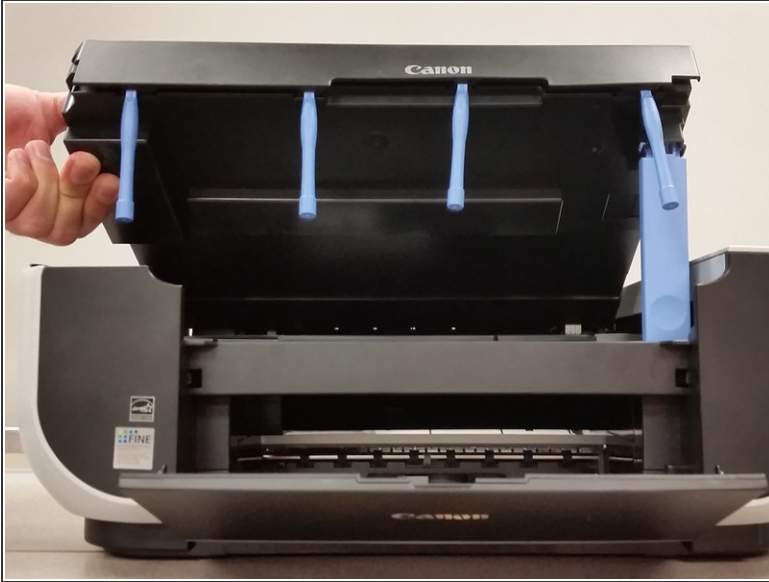
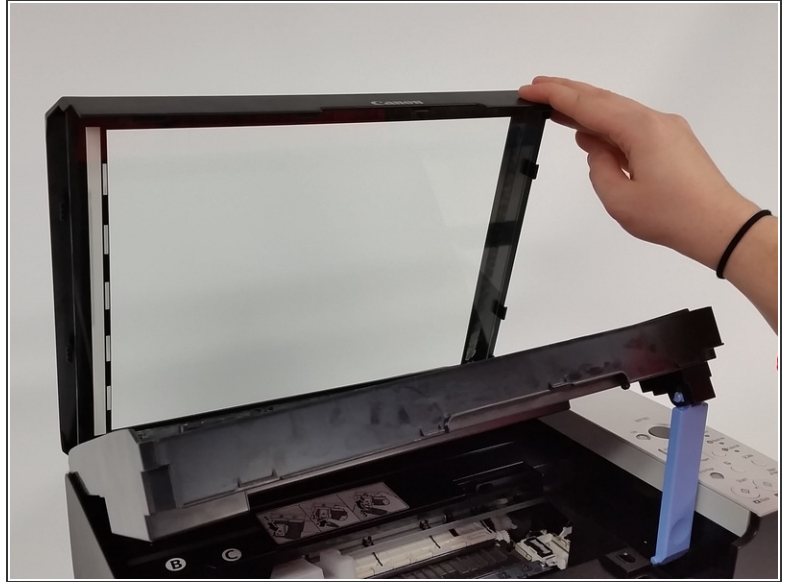
Step 3 — Accessing Scan Bed

- Place a plastic opening tool at each of the four marking arrows.
- The scan bed will detach from the scan bed unit. Lift scan bed glass upward to access the bottom surface of the glass.

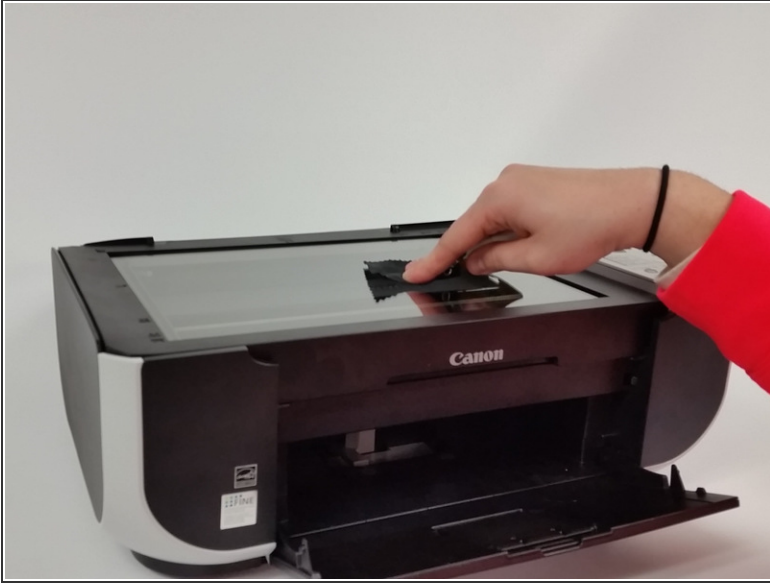
Step 5 — Reassemble Scan Bed Unit

- Lower the scan bed glass down on to the scanning unit until the clips reengage.
- Clean the top surface of the scan bed glass using the screen and device cleaner and cloth.
- Put the scan bed cover back on by placing the left hinge in first.
 - Then snap the right hinge into place.
- The printer is now ready to scan or copy.
